Supplementary regulation for wheelset bearing inspection as per VPI-EMG Module 04 Annex 15

Version: 1.2

As at: August 9, 2024

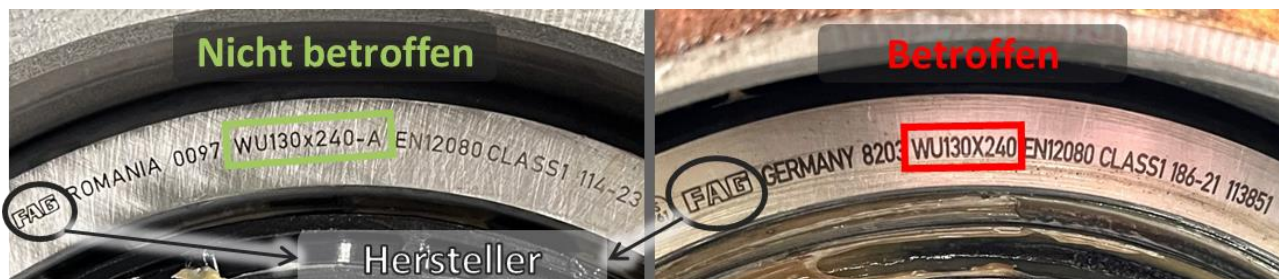
Figure 1: Identification

The cylindrical roller bearings affected are clearly identified by the marking WU130x240 on the outer ring (see Fig. 1). Cylindrical roller bearings marked WU130x240-A are not affected.

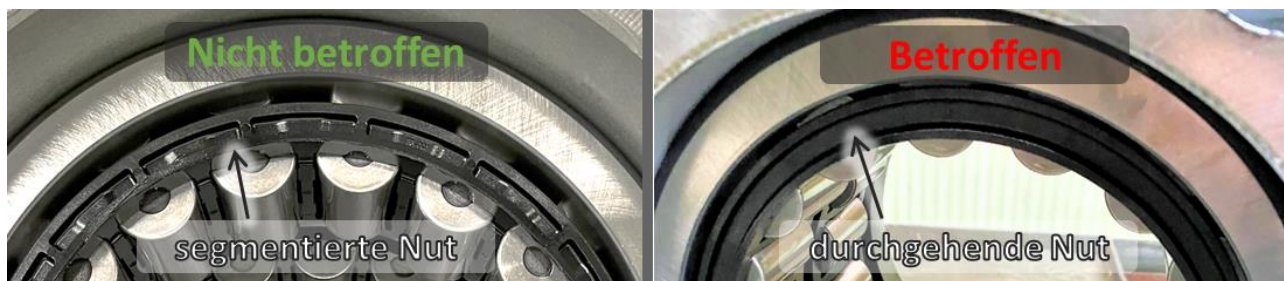
Figure 2: Cage as differentiator

The cage serves as an additional visual differentiator (see Fig. 2).

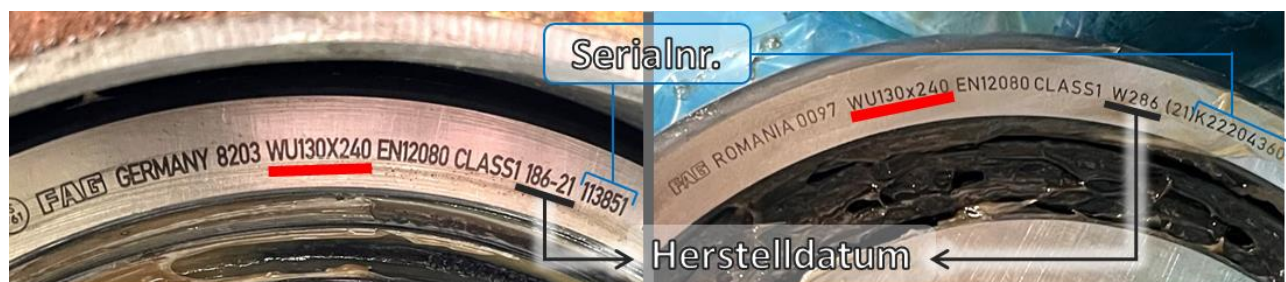
Figure 3: Date of manufacture

The exact date of manufacture of the cylindrical roller bearing is marked on the outer ring after “EN12080 CLASS1” using the canonical date format of three digits for the day followed by “-” (minus sign) followed by two digits for the year. A small number of bearings were marked with a “W” for the year 2022 instead of the two-digit format for the year (see Fig. 3).

For 2021: 158-21 to 365-21

For 2022: 001-22 to 365-22 or W001 to W365

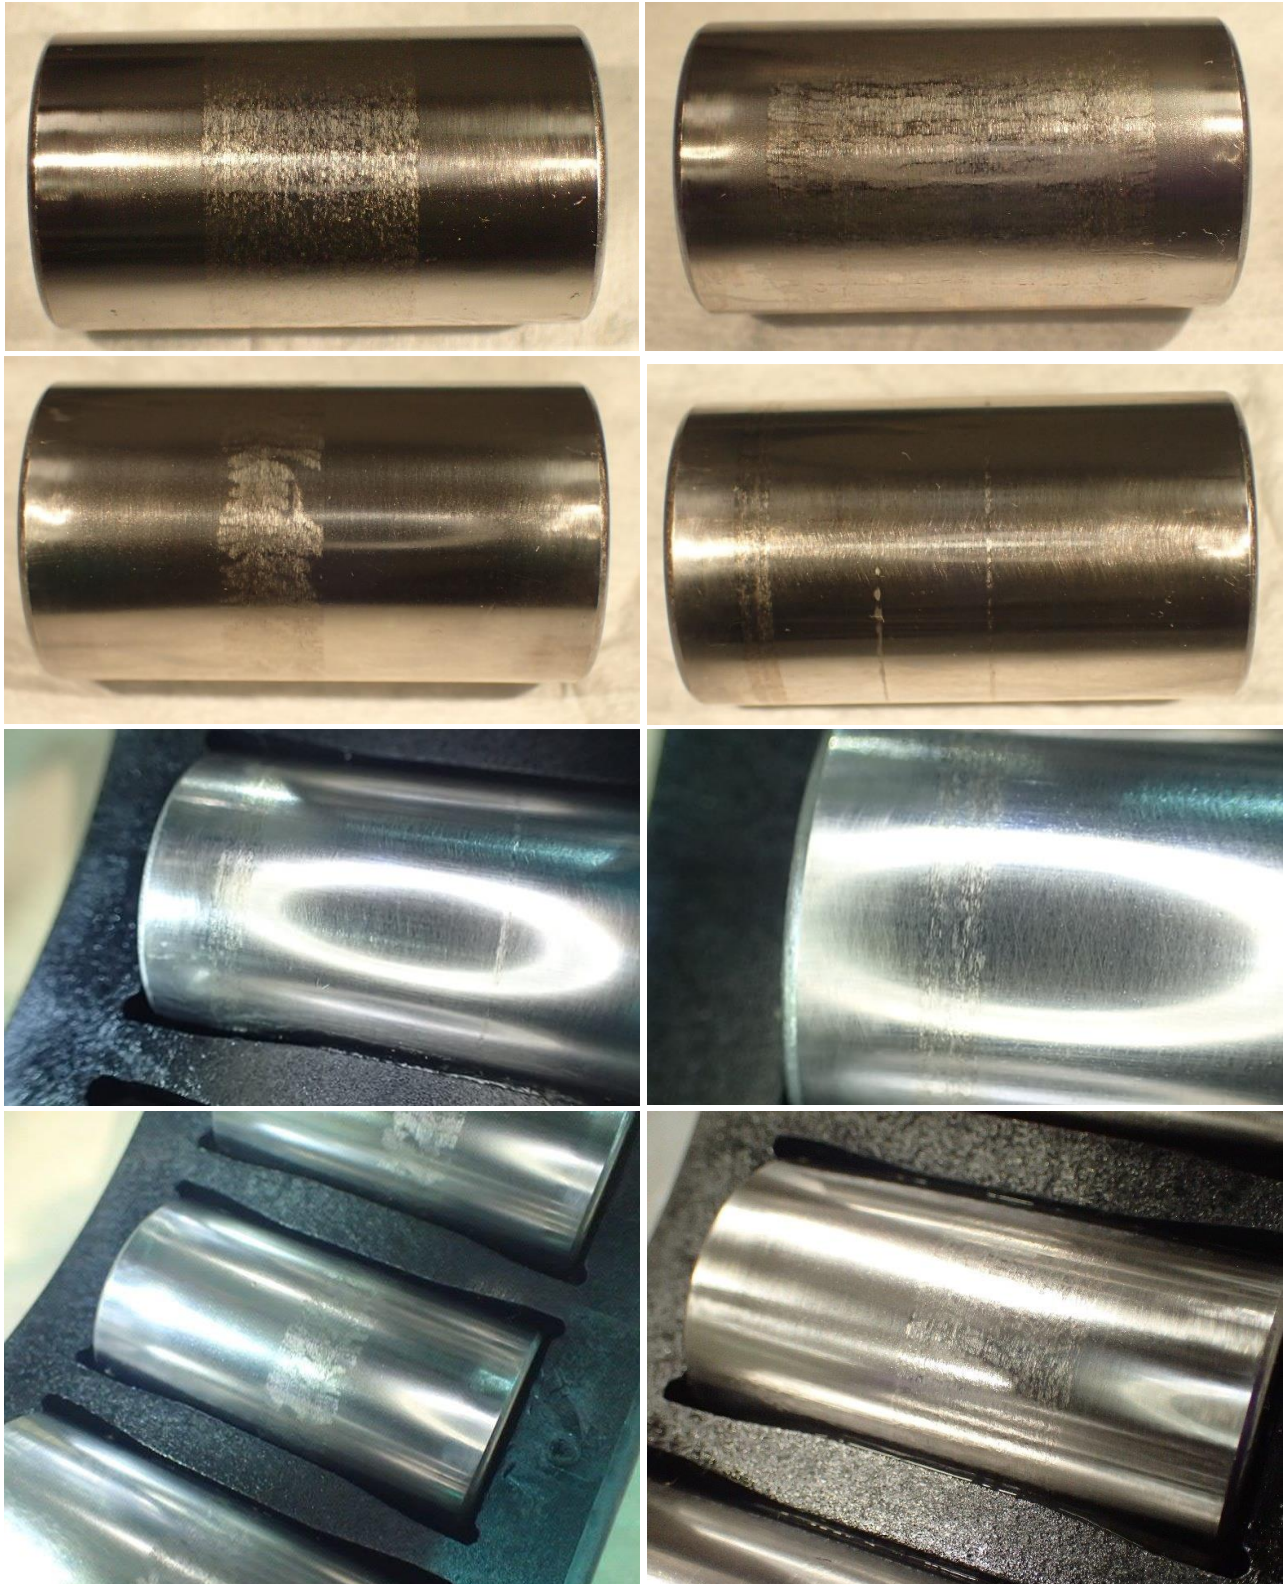
Figure 4: Slippage marks roller

The rollers exhibit a considerably roughened running trace. Slippage marks with a flake-like/scaly appearance can be seen over part or all of the roller surface (see Fig. 4).

Cylindrical roller bearings that exhibit the signs of damage shown in Section 3 (Fig. 4) are to be segregated and can then be scrapped. It must be ensured that the cylinder roller bearings that have been removed are not re-used (even inadvertently)!

The removed cylinder roller bearings should also be documented in addition to the “Wheelset Repair Sheet” (VPI-EMG Module 04 – Annex 26-1), (see next page).

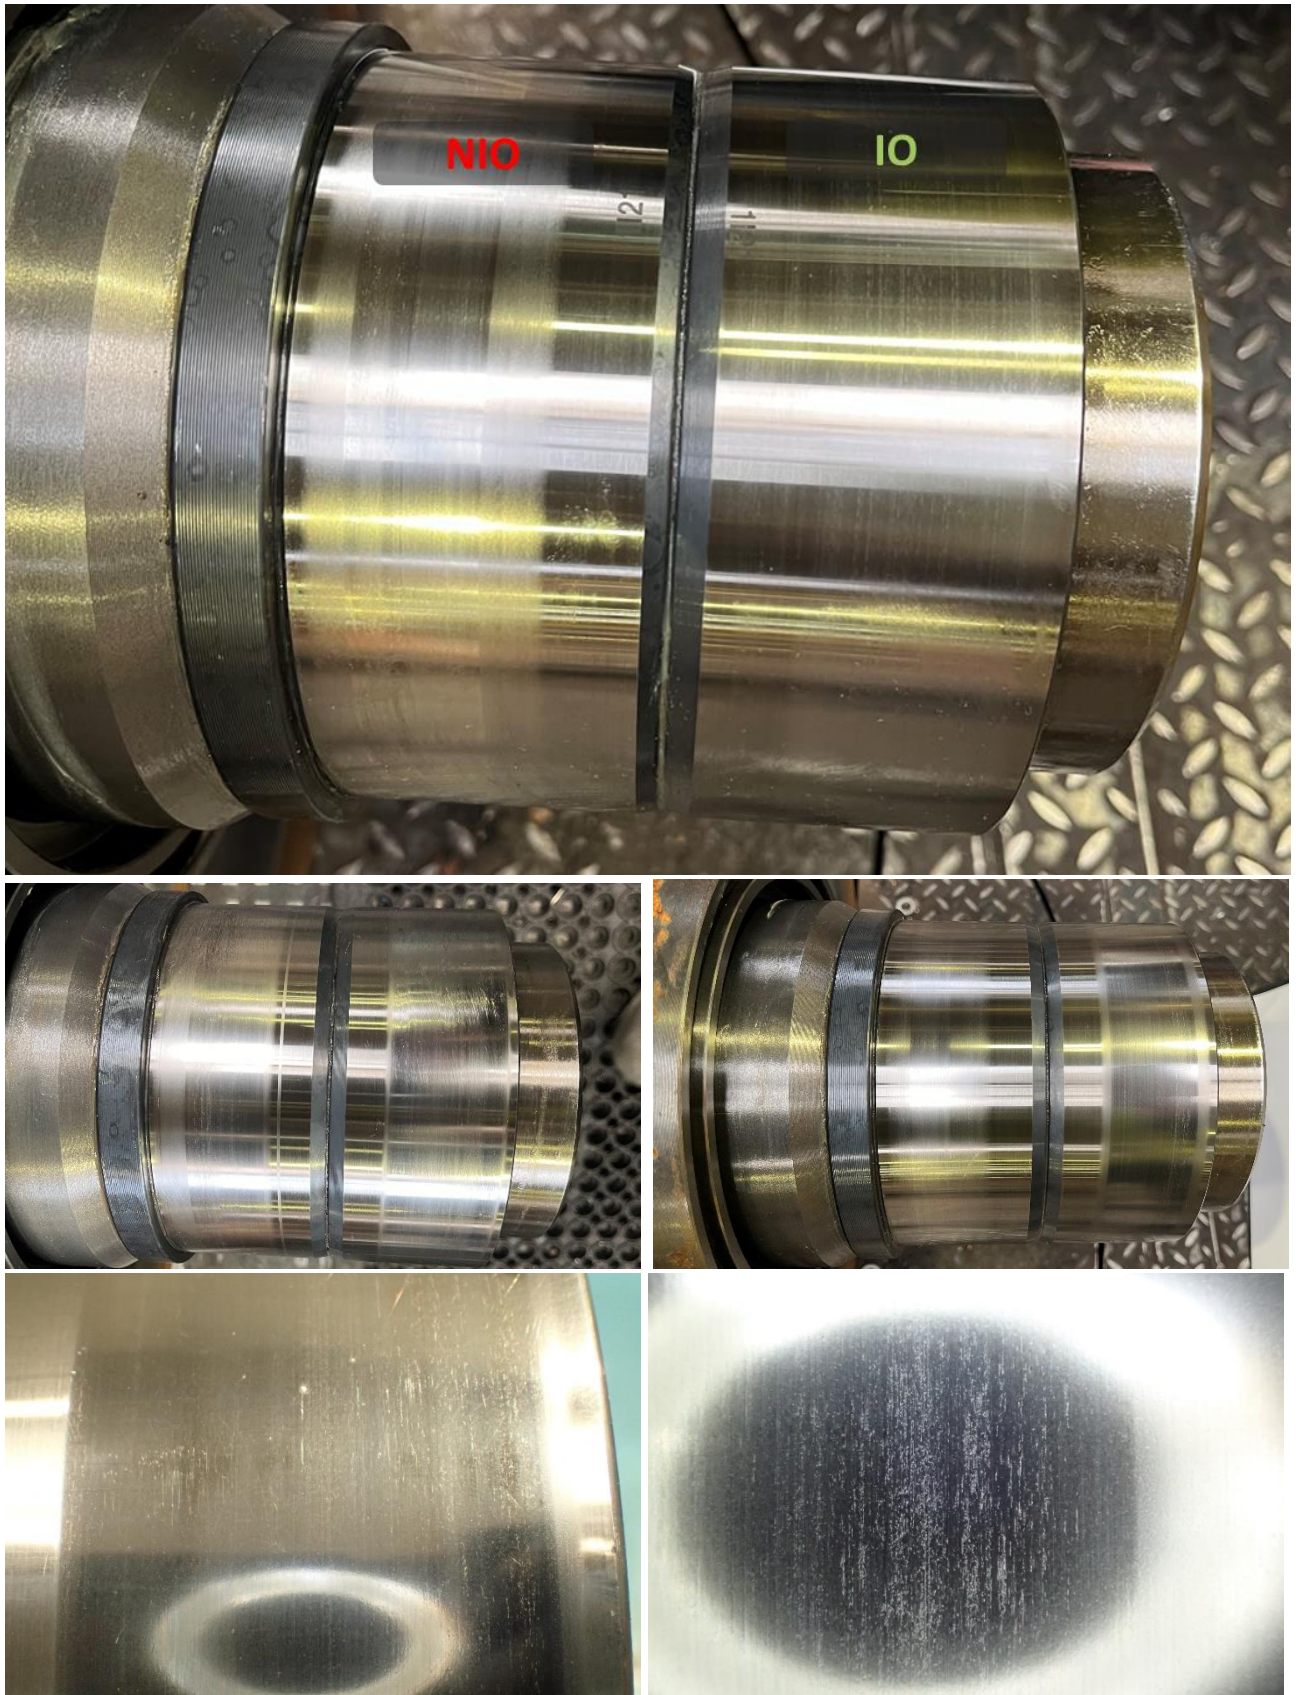
Figure 5: Slippage marks inner ring

The inner rings exhibit a distinct, dull circumferential trace with a roughened surface (see Fig 5).

Inner rings exhibiting the signs of damage shown in Section 3 (Fig. 5) must be removed from the wheelset shaft and can then be scrapped.

It must be ensured that these damaged inner rings are not re-used (even inadvertently)!
